Robson Forensic

Fire in Upscale Home

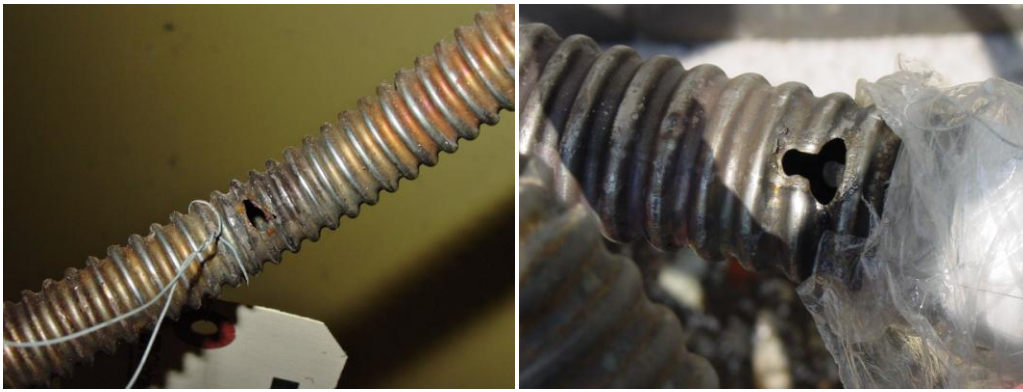
A fire broke out in a recently constructed upscale home during a heavy thunderstorm. Robson Forensic fire investigators were retained to investigate the fire and determine the origin and cause. Our investigator concluded that the origin of the fire was under the first floor where a hole was discovered in the flexible gas tubing. He determined that the hole had been created by a lightning strike. Based on these findings, additional Robson experts were engaged to determine if the work performed by the electrical contractor during the home's construction was a cause of the hole in the gas tubing.

Robson experts concluded that the gas piping system's bonding and grounding complied with all applicable building code requirements. Despite compliance with applicable codes, electrical arcing at the wall of the CSST caused ruptures in the piping at the origin of the fire. Robson experts determined that the electrical contractor's work met the applicable standard of care.
