**Investigation  
of the  
Elen - Thomas Collision**

**Report**

This two vehicle collision occurred at about 5:05 pm Month 5, 20\*\* on 2222 Street in Town, New York. The crash involved Thomas Thomas driving a 2004 Nissan Maxima and a 2002 Nissan Maxima driven by Elen Elen.

This investigation was performed to determine the severity of the collision.

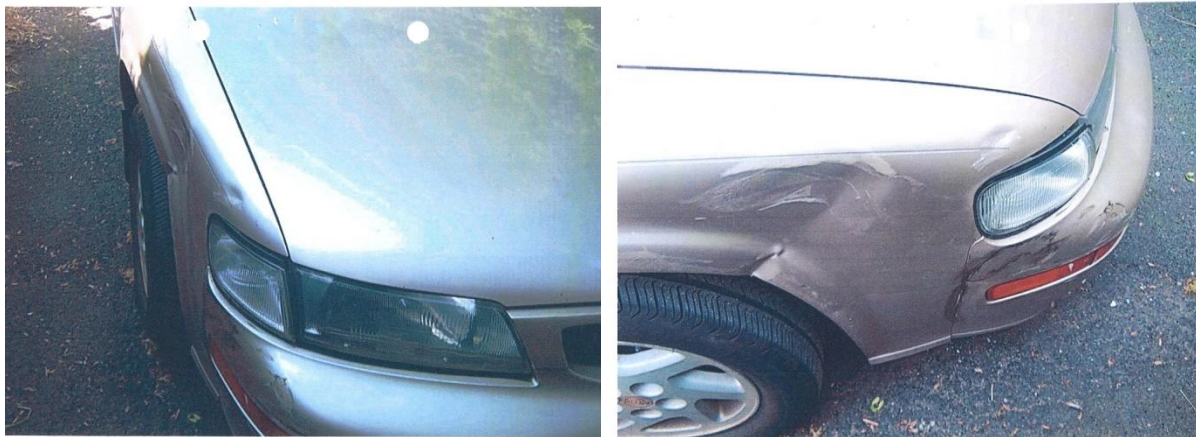
**Photos 2 & 3:** Elen's 1995 Nissan Maxima – Right side

As shown in Photos 2 & 3, Elen's Nissan had damage consisting of; a cracked right fog light and parking light, paint removed and black marks on the right side of the bumper cover, dents on the right front fender above the headlight and just forward of the wheel with paint removed to the top of the wheel well.

The repair estimate for Elen's Nissan consisted of a new right fender, right fog lamp assembly, parking lamp, signal lamp assembly, bumper cover, and right bumper bracket.

The damage to both vehicles indicates relative motion between the vehicles with no structural involvement. Both vehicles exhibit a contact damage length of about 20 inches. This minor damage is confined to the sheet metal. The fog light is induced damage from the impact to the bumper cover. Without structural damage, little energy was dissipated while damaging the non-structural fenders and door panel. The damage from the photos and repair estimates are consistent with a sideswipe collision.

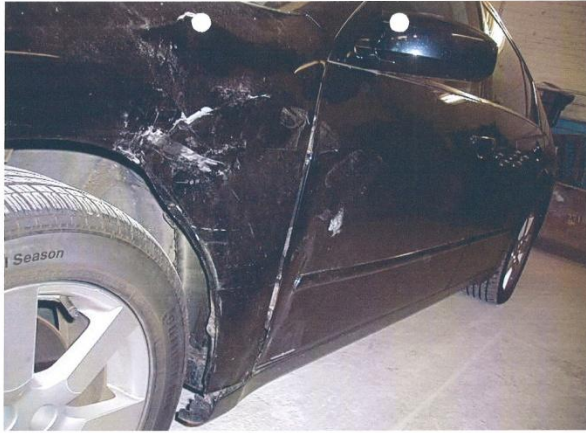
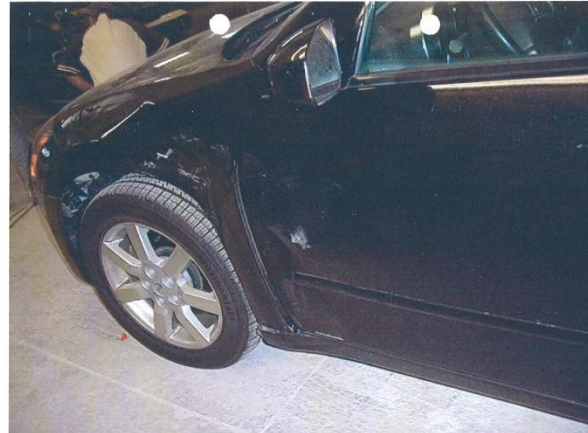
**Photos 4 & 5:** Thomas's 2004 Nissan Maxima – Left side

As shown in Photos 4 & 5, Thomas's Maxima had damage that extended from the driver's door underneath the rearview mirror and extended forward on the front fender to the top of the wheel well, with scuff marks on the wheel rim.

The repair estimate for Thomas's Maxima consisted of a new left fender, fender liner, left rocker panel molding, wheel, and labor to repair the door.

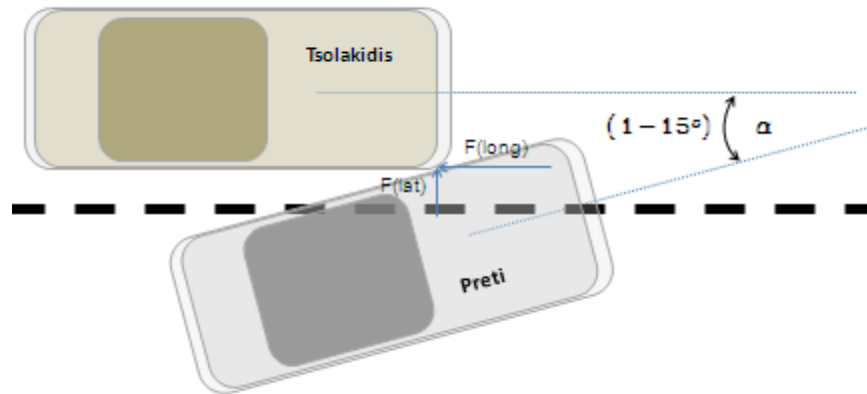
**Figure 1** – Estimated first contact and Elen’s Nissan force diagram

As the collision occurred, Elen's Nissan would experience a change in velocity laterally and longitudinally. As there is no impact damage on the front of Elen's Nissan, the impact angle between the two vehicles was a shallow angle (between 1 and 15 degrees)<sup>2</sup> and is shown in Figure 1.
