# INVESTIGATION OF THE MOTORCYCLIST/Car Driver COLLISION

## RECONSTRUCTION REPORT

July 31, 2010

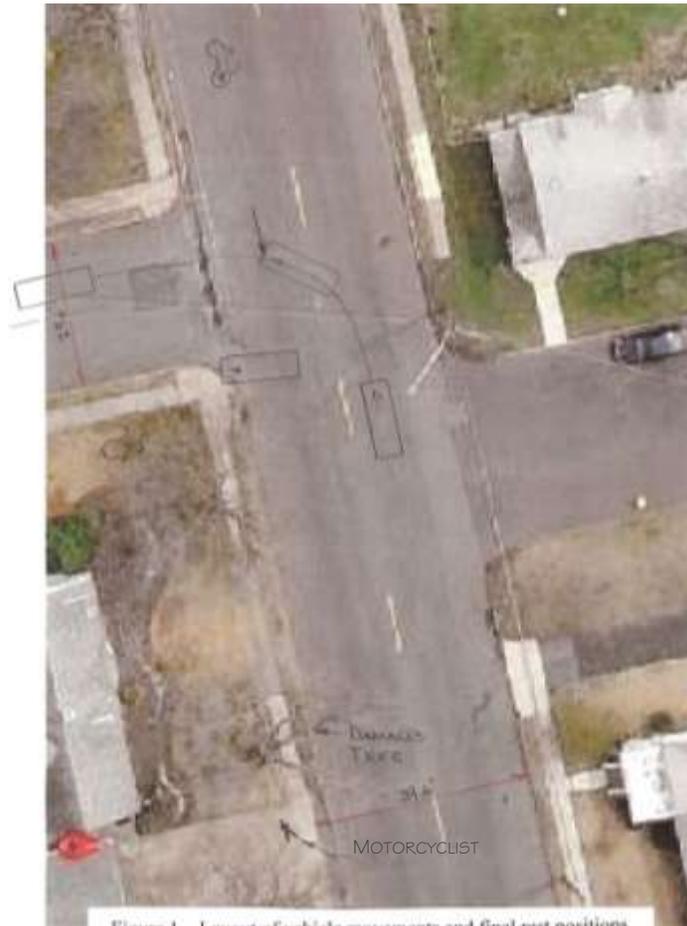
Figure 1. Layout of vehicle movements and final rest positions

Figure 1 is a to-scale aerial photo of the intersection, on which I have drawn the final rest positions of the car, the motorcycle and Motorcyclist, as well as the tree struck by Motorcyclist. Figure 1 also shows the path of Car Driver had she made a normal turn and the location of the Dodge and motorcycle at impact for this idealized turn. If impact occurred as shown in Figure 1, Motorcyclist travelled 94 feet to impact with the tree and his speed at impact was 38 mph.

For the purpose of analysis, I will assume Car Driver was making her left turn at a normal location and in a normal manner, as shown in Figure 1. With this turn, Car Driver would have travelled ~20 feet from a normal northerly path to impact. In the Police Report statement, Car Driver said that her speed at impact was 15 mph. In her response to Form C Interrogatories, Car Driver said that her speed at impact was 5 mph. For these speeds, Car Driver travelled the 20 feet in 0.9 to 2.7 seconds.

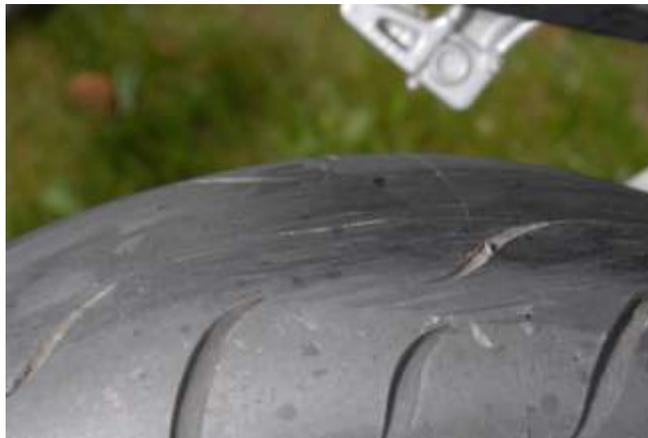
There was no documentation in the police report of Motorcyclist having produced a skid mark prior to impact. However, the photos of the motorcycle's tires, particularly No. 99, show that he did brake prior to impact.

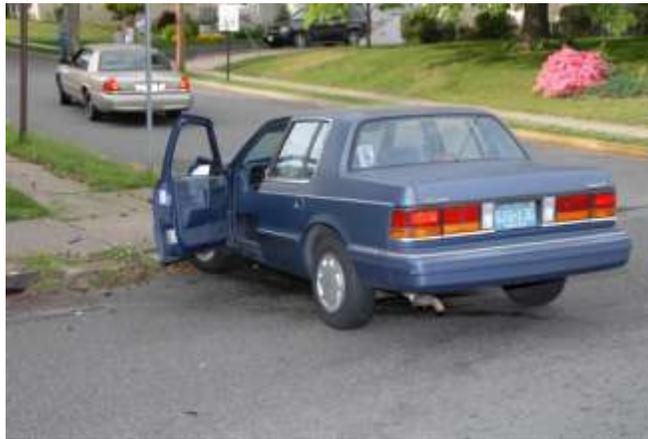
The final rest position of the car is against the curb at the southwest corner of the intersection. This is not a reasonable location for the car to have been hit. Therefore, there was post-impact movement by the car. This movement is evident in Photo No. 27.

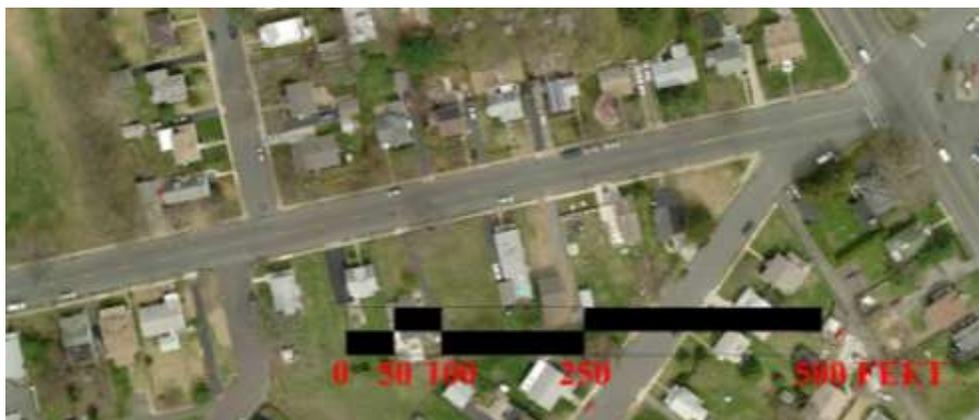
During the 0.9 to 2.7 seconds that Car Driver took to turn from a northerly direction to impact, Motorcyclist and his motorcycle were 45 to 150 feet from impact. The road geometry for Motorcyclist's approach is shown in Figure 2. As seen in the scene photos, it is easy to see from Dawes to Spruce Street, a distance of over 500 feet. Car Driver testified that there were no obstructions to her vision and that she could see almost to Spruce Street. Therefore, Car Driver should have seen the approaching Motorcyclist and his motorcycle. Yet, Car Driver said that she didn't see Motorcyclist and his motorcycle prior to impact.

Car Driver did not see the motorcycle that was there to be seen. Car Driver was not driving attentively.
