INVESTIGATION OF THE [REDACTED] BICYCLE CRASH

April 16, 2010

ENGINEER'S REPORT

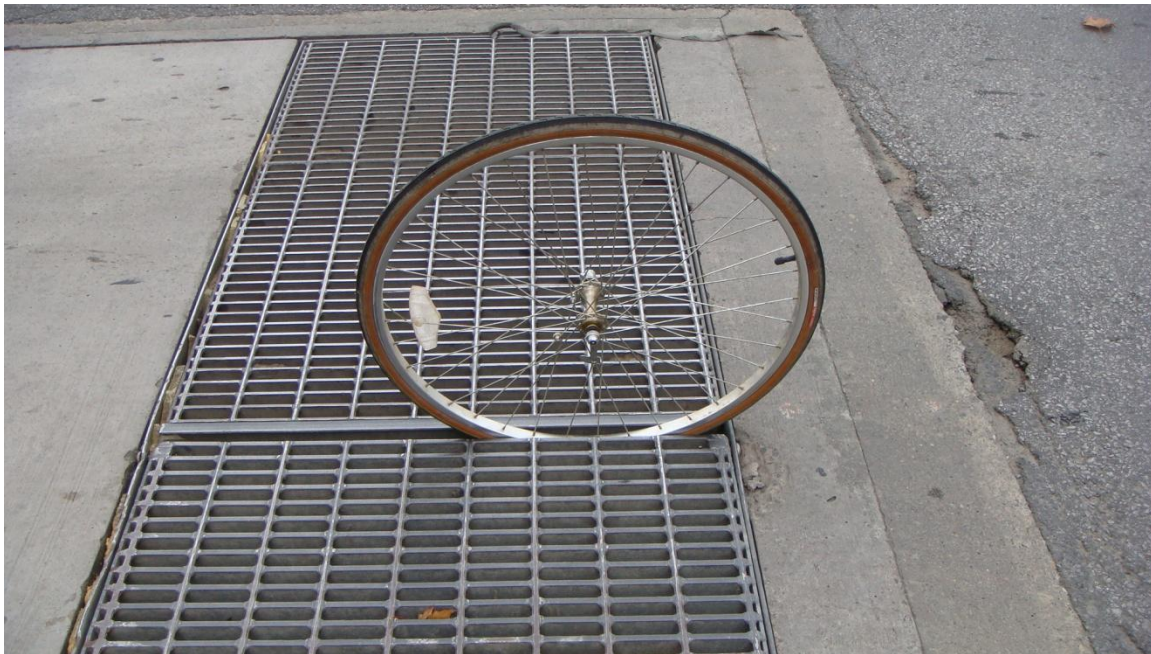
The involved grate is within the concrete top slab of an underground vault. The top slab is flush with the surrounding asphalt pavement and has an embedded steel frame supporting multiple grates. The grates are sized such that there are longitudinal (i.e., parallel to the direction of traffic) gaps. Within the concrete slab there are two rows of grates. For [REDACTED]'s direction of travel, his tire went into a gap in the far grate. The gap is 4' from the edge lines. The grate is 3'3" along the direction of travel. I measured the gap to be 1-1/16" wide. There was a piece of wood in the gap at my inspection. The photos I was provided show the front wheel of [REDACTED]'s bicycle down in the grate. I replicated this entrapment at my inspection with a 27 x 1-1/4" tire. This is not the narrowest of tires.

Photo 1. Typical bicycle wheel in the gap.

1. [REDACTED] was injured when the front wheel of his bicycle was entrapped in a gap in a National Grid grated facility.
2. The gap was 39 inches long by 1-1/16 inches wide, oriented parallel to the direction of traffic and at a location in the street where bicyclists should be expected to ride.

3. The gap in the National Grid grate created a condition long recognized as dangerous to cyclists, and made the National Grid grated facility dangerous in a manner that caused this crash.

4. Those responsible for the design, operation, and maintenance of the National Grid grated facility in Maple Street, should have recognized the unsafe condition created by the gap in the grates with the opening parallel to the direction of travel, and should have corrected same.

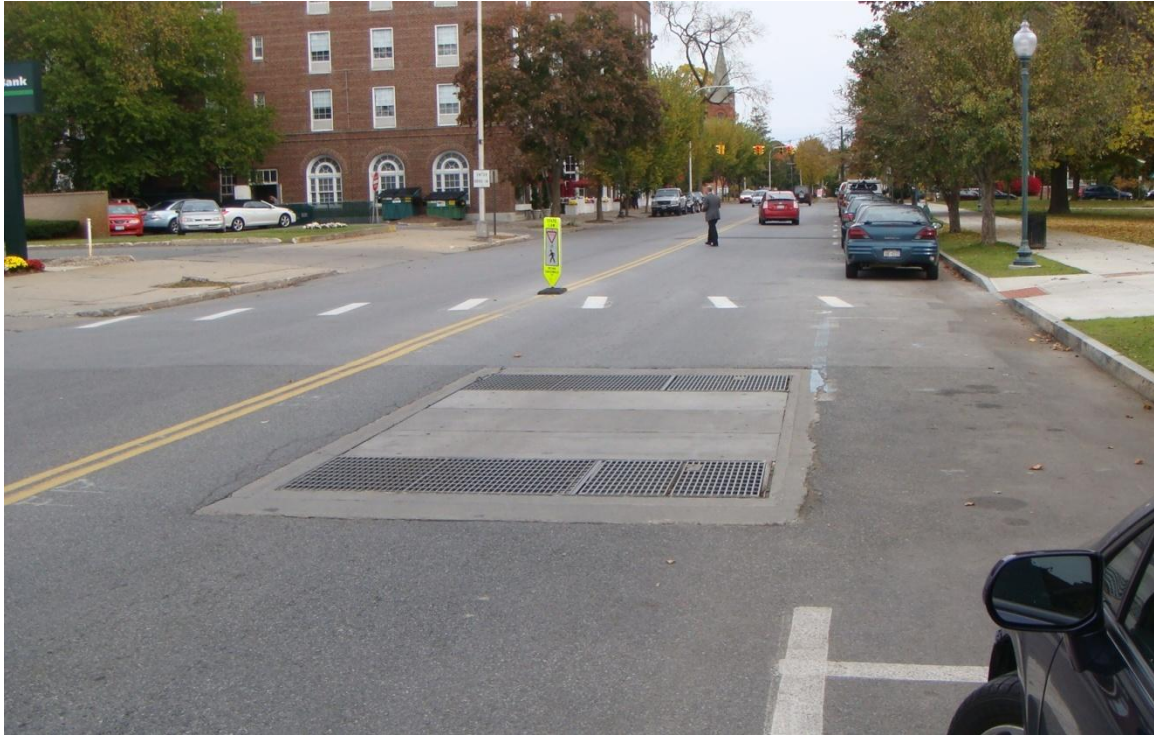
The grate encountered by [REDACTED] is part of two similar installations in the westbound travel lane of Maple Street, between Ridge and Bay Streets. The grate that his tire entered is located across the street from the Adirondack Trust Company.

Photo 2. Position of grate in the street.
