Robson Forensic

WORK ZONE COLLISION

This bicycle/motor vehicle construction work zone collision resulted in the fatality of the bicycle driver. Liability was established against both the construction contractor and the design engineering firm.

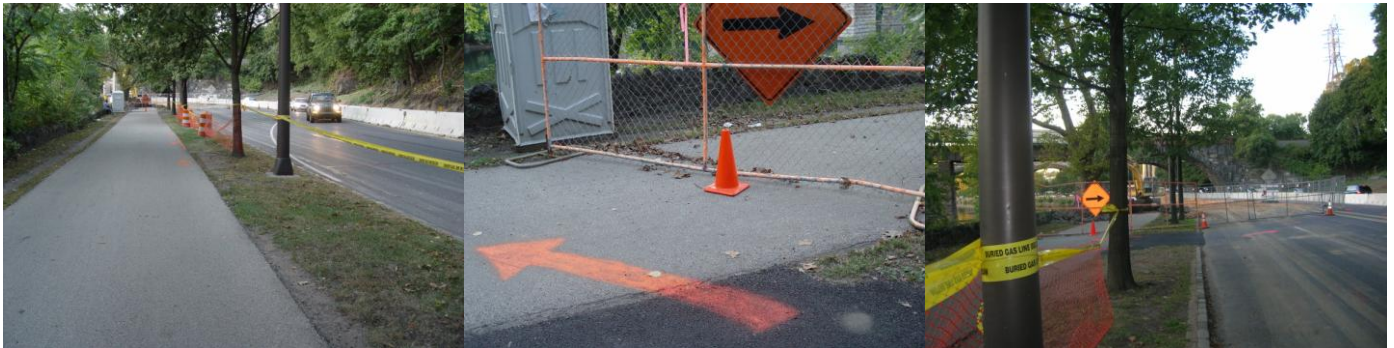
We determined that the collision occurred when the bicycle driver, while riding on a long-established pedestrian/bike path adjacent to a 4-lane thoroughfare, and upon entering the construction work zone, traveled into the oncoming motor vehicle travel lane and was struck by an automobile.

On the night of the crash, the following conditions existed:

- There were no advance warning signs or devices on the recreational pedestrian/bike path northbound in advance of the construction work zone.
- There were no channelization or directional devices on or along the recreational pedestrian/bike path northbound in advance of the construction work zone.

- There were no pavement markings or pavement delineation on or along the recreational pedestrian/bike path northbound in advance of the construction work zone.

- There was misleading guidance at the point where the redirected/detoured path transitioned into the construction work zone.
- At the transition of the redirected/detoured path into the work zone, the temporary path was not detectable and did not include accessibility features consistent with the features present in the existing pedestrian/bike path.

- There was no temporary lighting to assist the biker as he navigated through the transition into the temporary path.

The contract documents required the recreational pedestrian/bike path paralleling the thoroughfare to remain open, usable and safe at all times during construction. Traffic control plans, depicting the word “SAMPLE”, were prepared to protect users of the pedestrian/bike path during construction; these “SAMPLE” plans were included in the contract documents and were utilized in the early stages of the project. Based on the facts and in accordance with standards for work zone traffic control, our expert opined that the contractor and the design firm neither updated nor detailed the “SAMPLE” traffic control plans in accordance with appropriate local, state and federal standards for detours/rerouting of pedestrian/bike paths within a construction work zone. The failure of the contractor and the design firm to employ reasonable and established measures to effectively redirect pedestrian and bike traffic through the construction work zone was improper and a substantial cause of the collision and fatality. The case settled during mediation.
