**Investigation
of the
Tania-Jose Collision**

Investigation of the Tania-Jose Collision

Report

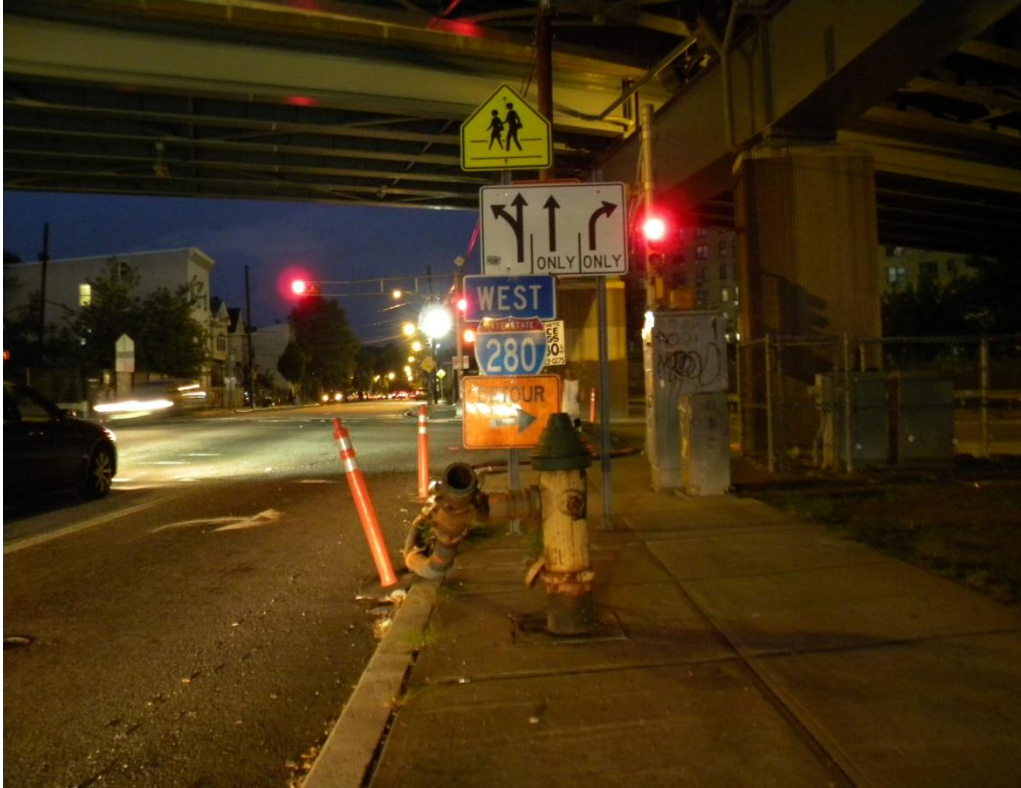
Photo 1 shows the signs viewed northbound on 11111 Street.

Adjacent land use consists of both commercial and residential buildings. There are two schools within 500 feet, three playgrounds within two blocks, and the Towne Light Rail train station is 325 feet east on 22222 Street. There is a pentagon shaped warning sign of a school zone crossing with a fluorescent yellow-green background at the intersection on the south east corner of 11111 Street.

As the area is a busy intersection with many pedestrians and the roadway signage shown Photo 1 is for a school zone crosswalk, Jose should have been looking for pedestrians. The New Jersey driver's manual states:

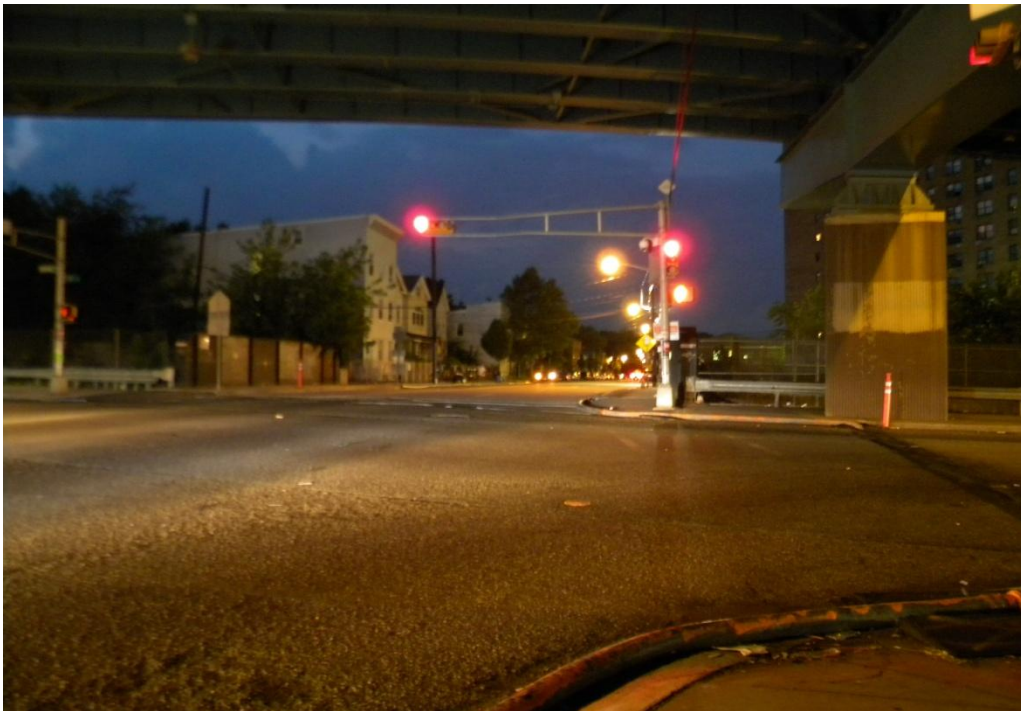
Photo 2 shows the view northbound on 11111 Street.

The following Photos illustrate the conditions at 45 minutes after sunset. The time of the collision was about 5:30 pm in Month. Sunset on that day was 4:53pm⁸. These photos were taken when the light was consistent to the time of the crash. It was dark and vehicles had their headlights on.

There is lighting from four mounted lights underneath the overpass and ambient lighting from pole mounted lights on 11111 Street, pole mounted lights on I-280, and the nearby businesses. With the crosswalk 62 feet from the stopline, pedestrians are both illuminated by the overhead lighting and well within the range of vehicle headlights. Even darkly clothed pedestrians would have been easily seen in the north crosswalk on 11111 Street.

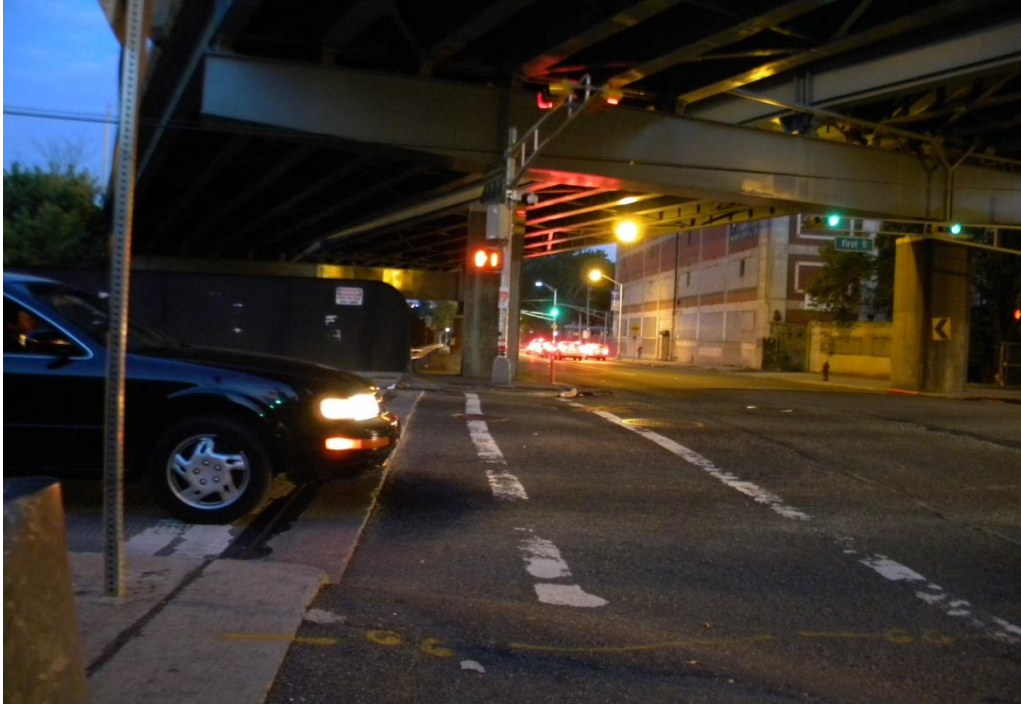
Photo 3 shows the impact area and crosswalk viewing east.
