ENGINEER'S REPORT
of the
Left Rear Passenger COLLISION

January 14, 2010

This single-vehicle run-off-the-road crash occurred June 15, 2006, at about 2:20 *p.m.* on Glenwood Avenue, in City, NH. The crash involved a 1995 Hyundai two-door hatchback, driven by Driver, and occurred within a construction work zone. Left Rear Passenger was injured as a result of the crash.

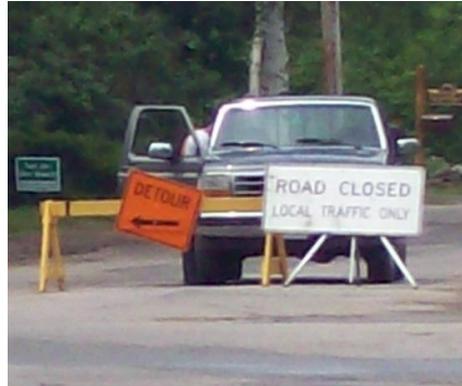
Contractor appears to have had available a sign that said Road Closed, Local Traffic Only as seen in the extract from the photo in Exhibit Camarato 2 below, as opposed to Local Traffic Only

as shown on their TRAFFIC CONTROL & CONSTRUCTION SIGNS submittal. Note that this photo was taken 6/23/06, a week following the collision. There is no claim that Glenwood Avenue was closed with a barricade the day of the collision.

The sign used by Contractor is similar to R11-3, with the distance to the closure point omitted.

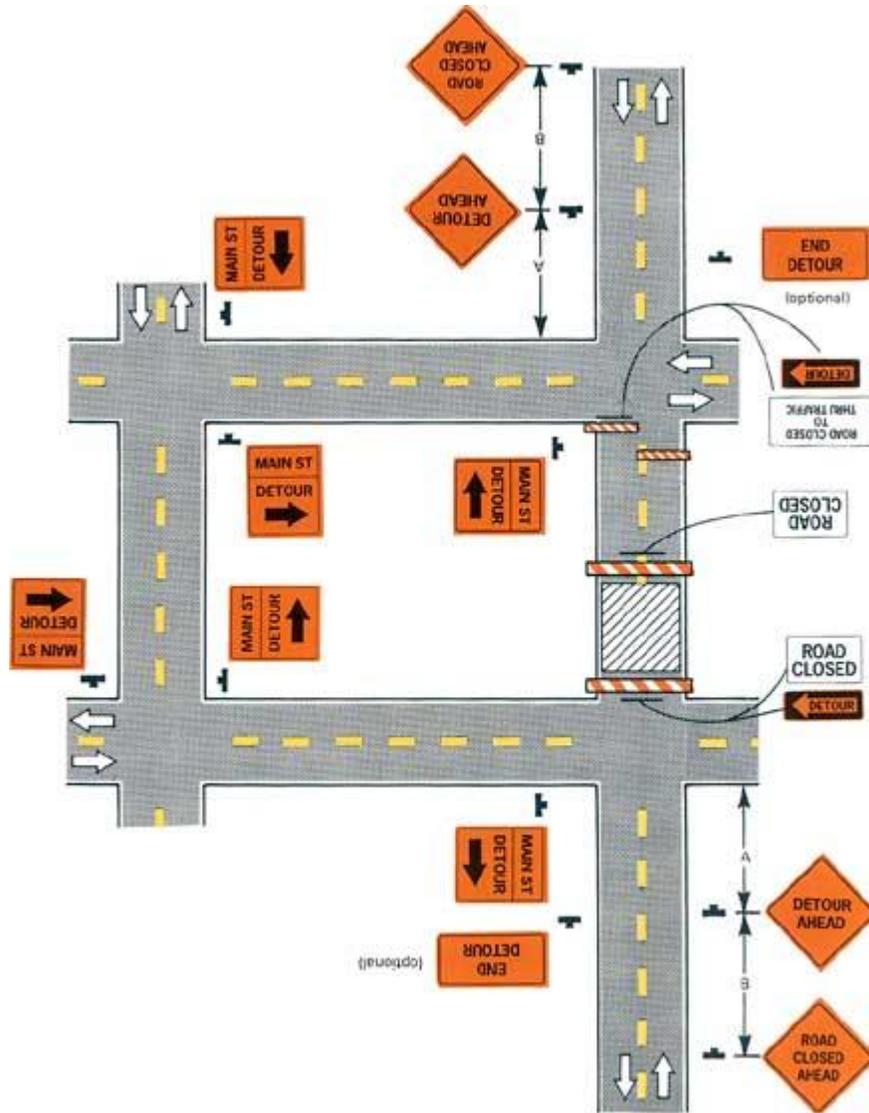
Figure TA-20. Detour for closed street

Detour for Closed Street

1. Display similar signs and devices for the opposite movement.
2. Use this plan for city streets and for county or township roads. See figure TA-9 for the procedure for detouring a numbered highway.
3. The use of a street name sign mounted with the M4-9 DETOUR sign is optional. When used, the street name plate is placed above the DETOUR sign. The plate may have either a white-on-green or a black-on-orange legend.

4. An M4-9 DETOUR sign with an advance turn arrow may be used in advance of a turn. On multilane streets, such signs should be used.
5. Flashing warning lights and/or flags may be used to call attention to the advanced warning signs.
6. Warning lights may be used on Type III barricades.
7. M4-9 DETOUR signs may be located on the far side of the intersections.

The orange cross-hatched devices shown at the Road Closed to Thru Traffic sign are barricades

Glenwood Avenue should have been closed to through traffic as shown on Typical Application - 20, with Type III barricades at Whittier Street. Positioned as shown on TA-20 the barricades constitute a traffic calming measure called a chicane¹¹. Chicanes are used for speed reduction and together with positioning of the sign would have been an effective deterrent to through traffic such as Driver¹². In addition the black and white sign is a regulatory sign. Regulatory signs give notice of traffic laws or regulations which are enforceable by police.

Engineer should have instructed Contractor to employ barricades and signs as in TA-20 to effectively close the road to local traffic.

7. Contractor and Engineer should have taken effective steps to detour the non-local traffic.
8. Glenwood Avenue should have been closed to through traffic using provisions shown in TA-20 of the 1988 MUTCD, Revision 3 of 1993.

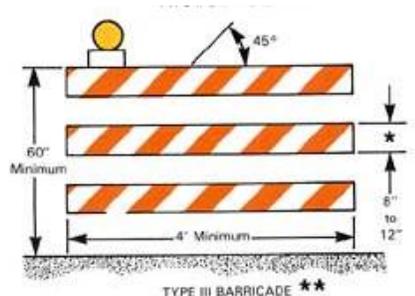
A Type III barricade has three striped rails and is at least 5' high and 4' wide, as seen in the following extract from the MUTCD.

- * Nominal lumber dimensions are satisfactory for barricade rail width dimensions
- ** Rail stripe widths shall be 6 inches except where rail lengths are less than 36 inches; then 4 inch wide stripes may be used.
- The sides of barricades facing traffic shall have retroreflective rail faces
